Special Council Meeting

## SHIRE OF VICTORIA PLAINS LOCAL PLANNING SCHEME NO.5

# EXCAVATION and REHABILITATION MANAGEMENT PLAN.

## LOT 668 Mogumber – Yarrawindah rd, Mogumber

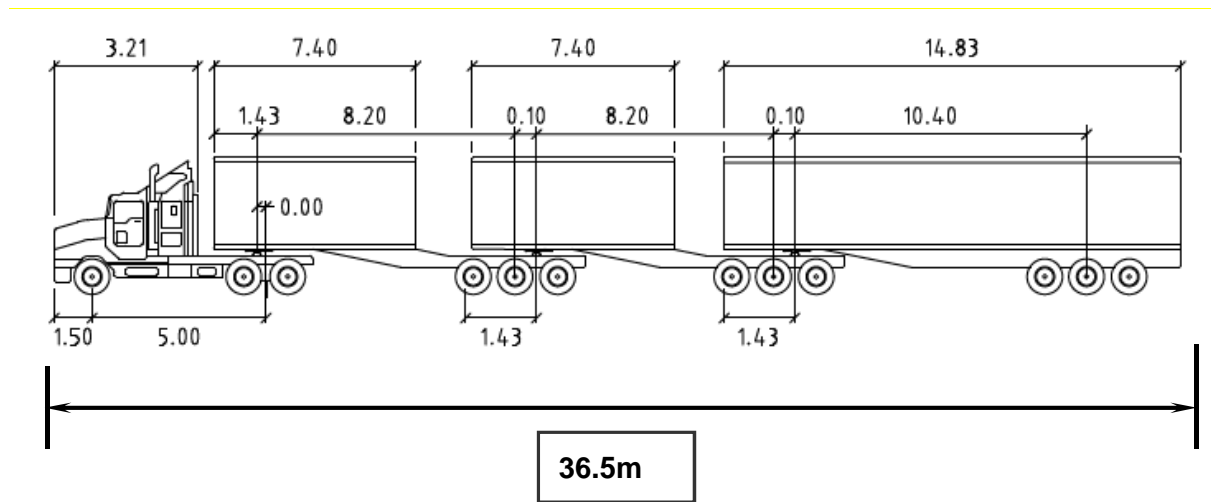
**Figure 3** – Demonstrates a typical vehicle combination that is used on the MRWA RAV 5 road network.

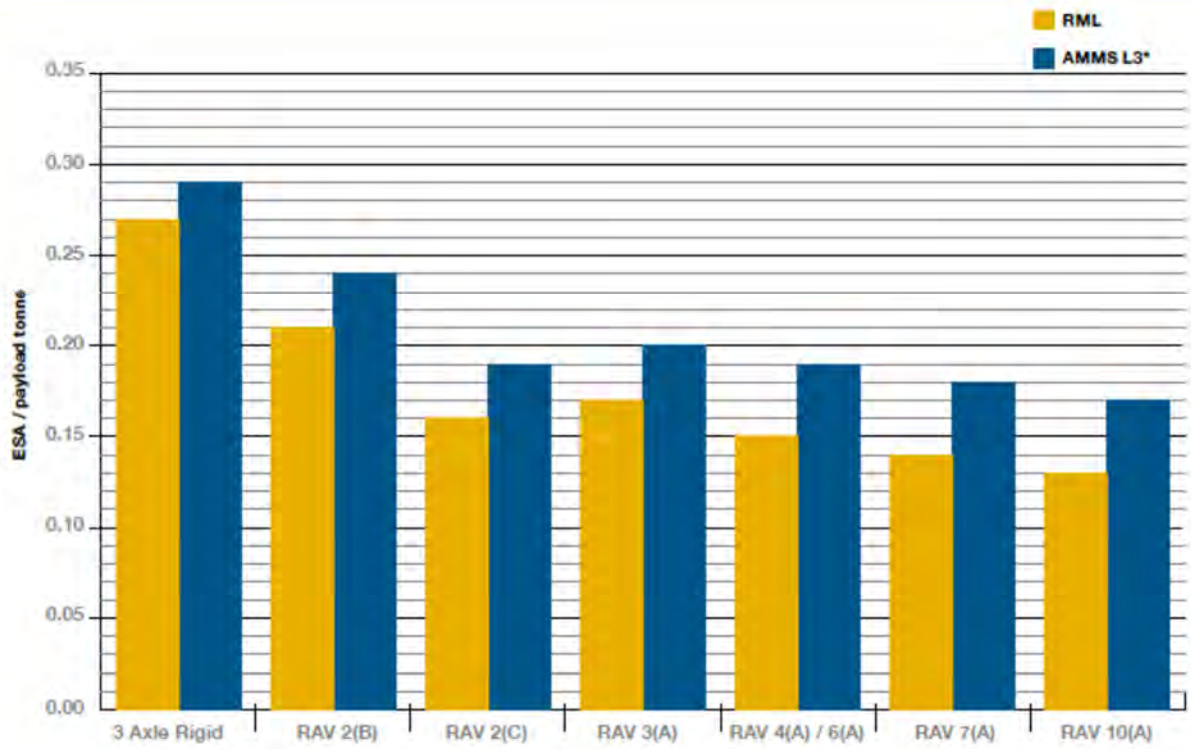
Figure 3: ESA per payload tonne for different vehicle types and loading schemes.

\*Note: The AMMS has three levels. The displayed values are for Level 3. If the vehicle is operating at a lower level then select a proportionate value between the RML value and the AMMS L3 value

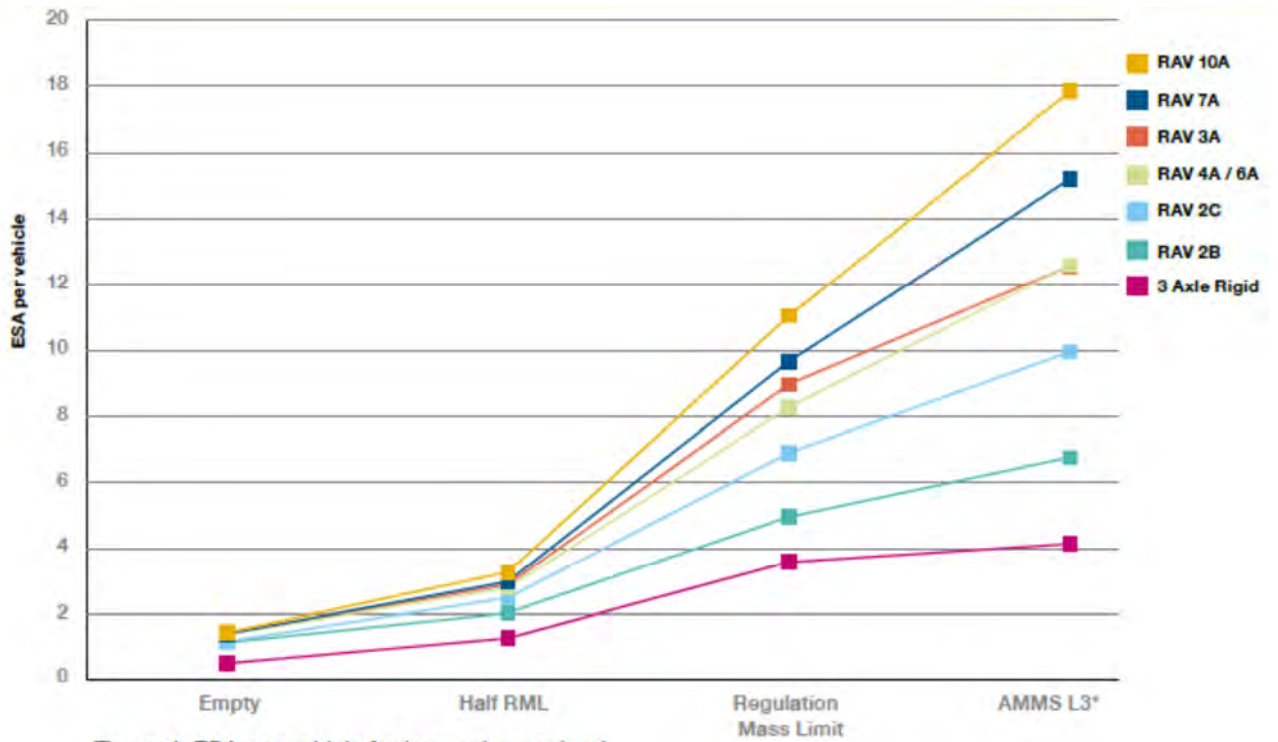
Figure 4: ESA per vehicle for increasing payload

\*Note: The AMMS has three levels. The displayed values are for Level 3. If the vehicle is operating at a lower level then select a proportionate value between the RML value and the AMMS L3 value.

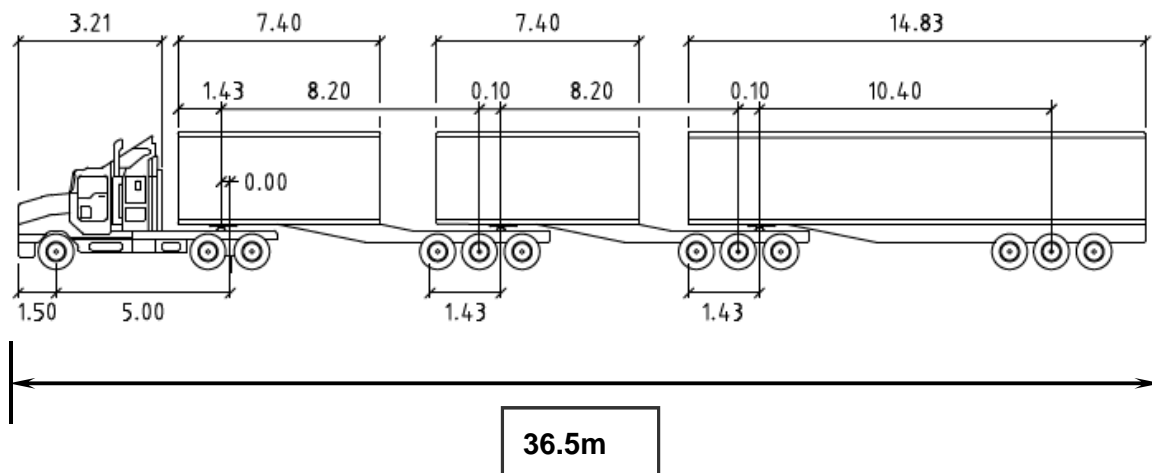
**Figure 3** – Demonstrates a typical vehicle combination that is used on the MRWA RAV 5 road network.

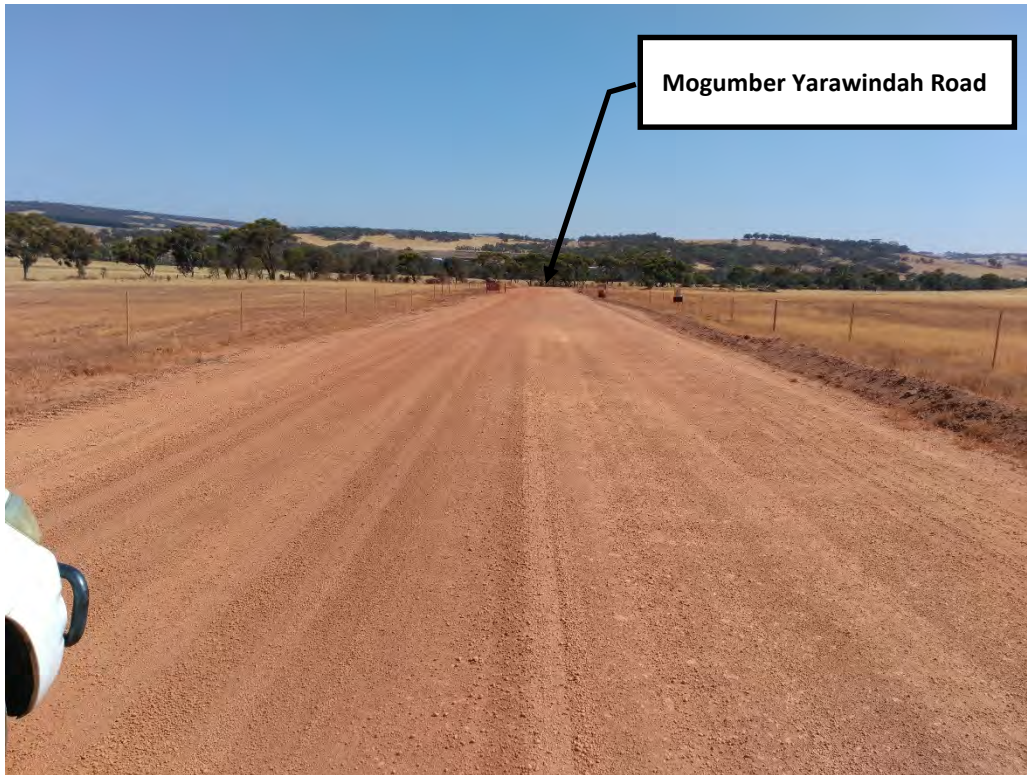
PHOTOGRAPH 5 7.95 SLK Looking North along Menzies Pit Driveway towards Mogumber Yarawindah Road

- 3) There is a downgrade on Menzies Pit Access on approach to the Mogumber Yarrawindah Rd , and it is difficult to see the approaching intersection . Refer Photograph 5  
To mitigate the safety risk of vehicles not slowing down to allow safe stopping at the junction, it is recommended to install an advance warning intersection warning sign on the Menzies Access, and a Hazard Marker sign No MR-HM-2 on the northern verge opposite the entry point
- 4) There is no guide sign ( finger board) on the northern road verge to identify the Menzies Pit entry

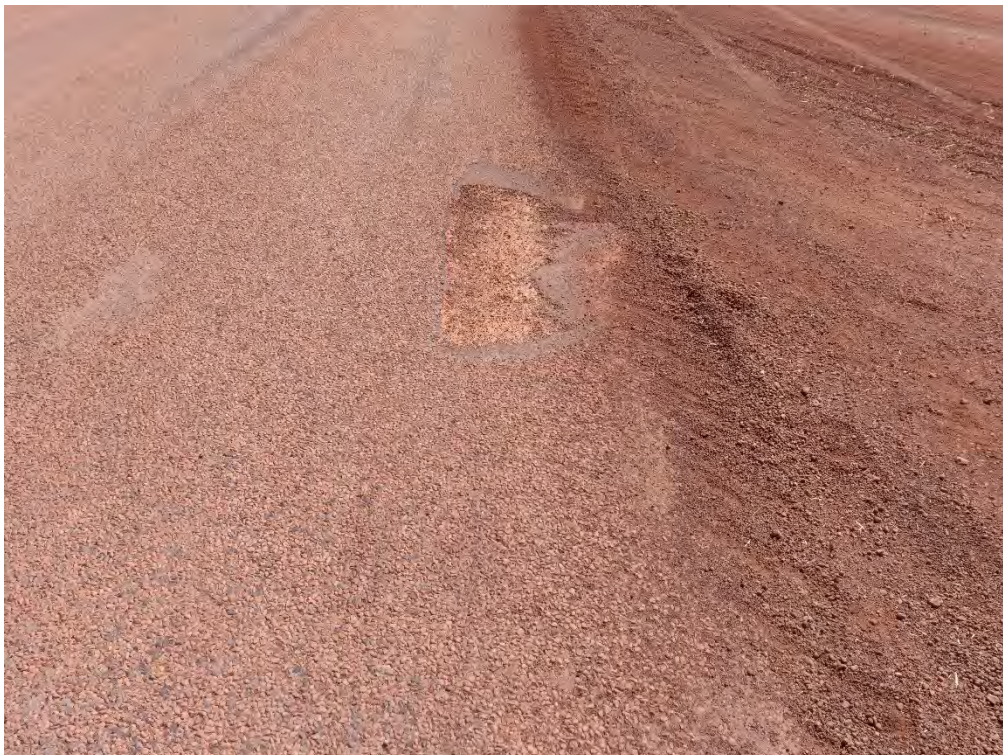
PHOTOGRAPH 6 7.95 SLK Seal damage at Menzies Pit Driveway on Mogumber Yarawindah Road

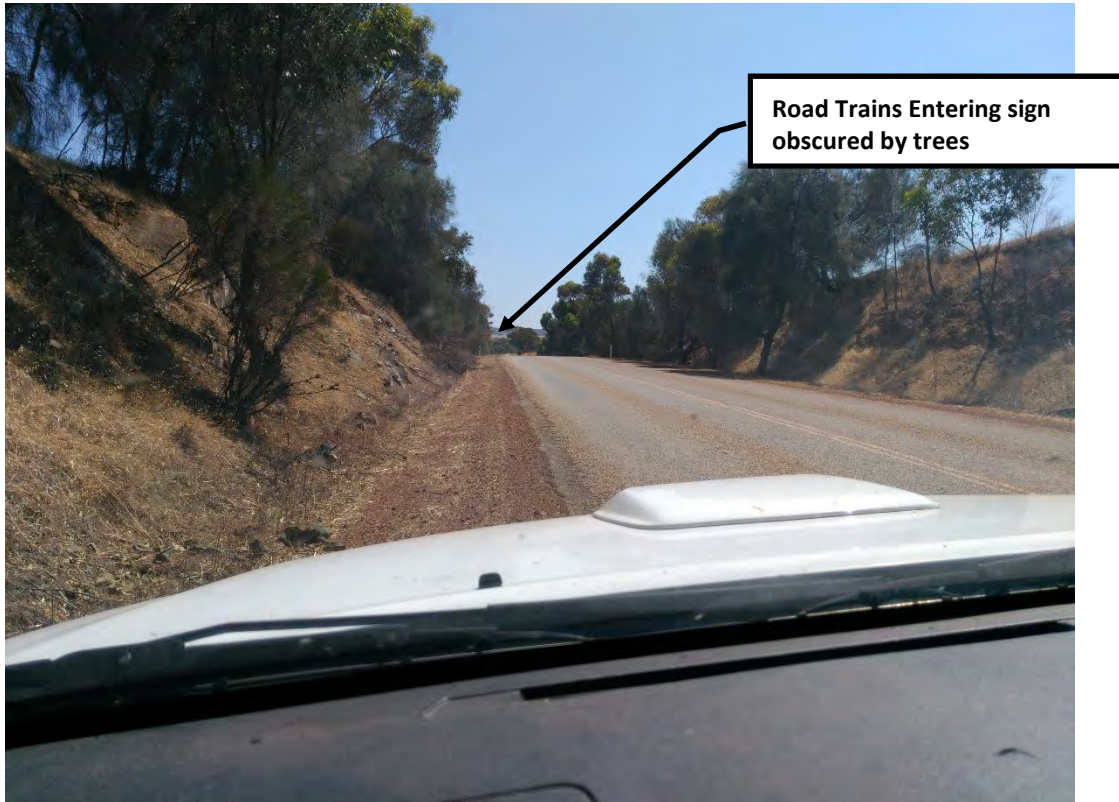
PHOTOGRAPH 10 "ROAD TRAINS ENTERING" sign on western approach along Mogumber Yarawindah Road obscured by trees

- 1) The existing advance warning heavy vehicle (Road Train) road signs on Mogumber Yarawindah Rd on the western approach, is obscured by road side vegetation. Refer to Photographs 10 and 11
- 2) The existing advance warning heavy vehicle (Road Train) road signs on Mogumber Yarrawindah Rd for both the eastern and western approaches, requires distance drop tags placed on the bottom of the sign panel to conform with the Australian Standards

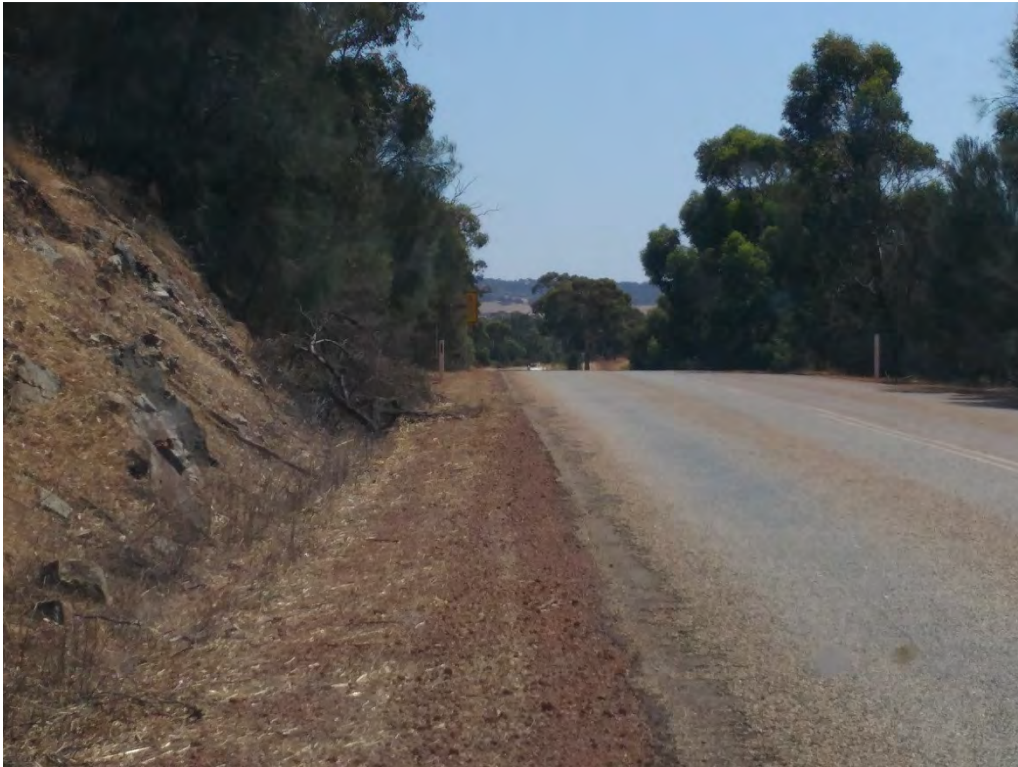
PHOTOGRAPH 11 Road Trains Entering Sign 7.56 SLK obscured by vegetation

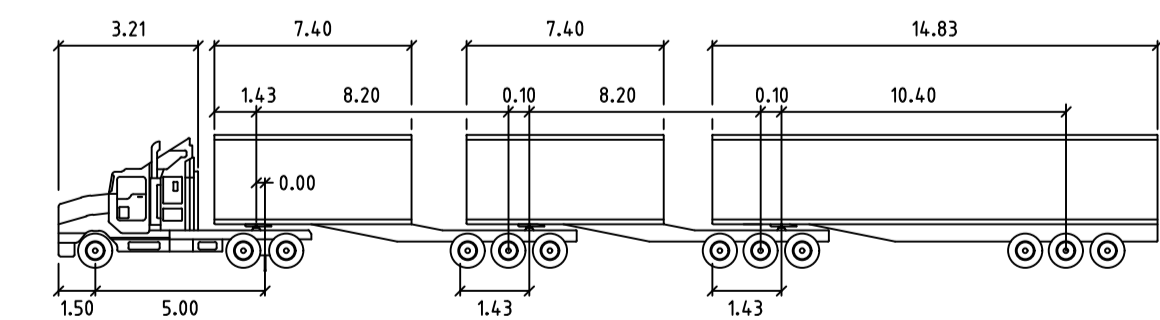
RAV 5 36.5m B-TRIPLE ROAD TRAIN

MINIMUM TURN RADIUS TO  
OUTER FRONT WHEEL = 15m
